**Re: Martville Mine – 13181 Sanford Road, Martville, New York
Compliance Evaluation Inspection – August 21, 2015
SPDES Tracking No. NYU215901**

COMPLIANCE EVALUATION INSPECTION REPORT

Compliance Evaluation Inspection: Martville Mine	
Inspection Date: August 21, 2015	Inspection Time: 10:30 AM
EPA Inspector: Katherine Mann, Physical Scientist, USEPA Region 2, DECA, Water Compliance Branch (212) 637-4226	
NYSDEC Region 7 Representatives: David Bimber, Regional Permit Administrator, Division of Environmental Permits; and John Clancy, Environmental Analyst, Division of Environmental Permits	
On-Site Representative: CJ Ferlito, Owner	
Site Information: 13181 Sanford Road, Martville, NY 13111 SPDES Tracking No. NYU215901	
Owner/Operator: Christopher J. Construction, LLC	
SIC Code: 1442 - Construction Sand and Gravel

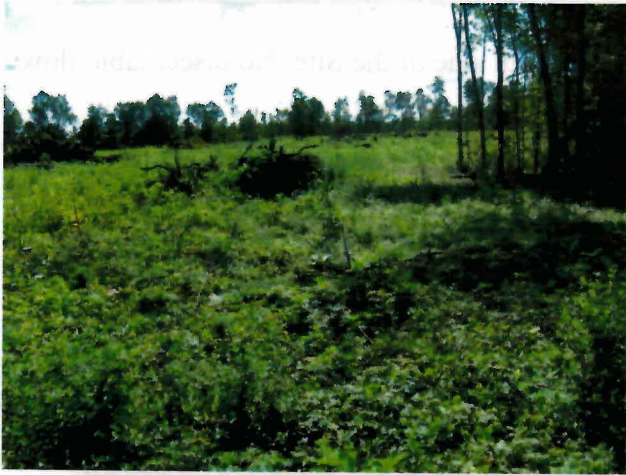
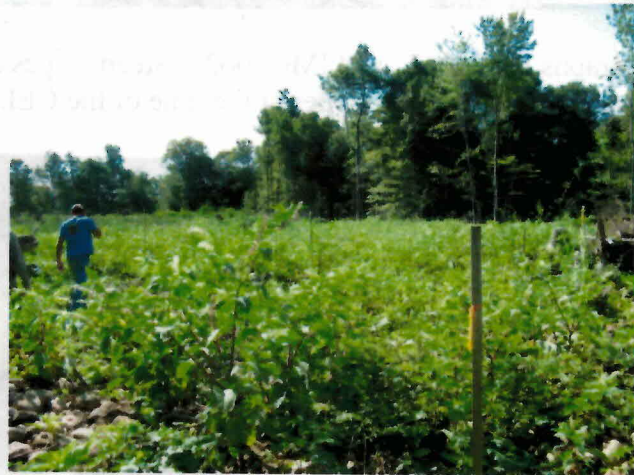
At the time of the CEI, Mr. Ferlito stated that a portion of the Site was lumbered in late fall, early winter of 2014. As identified in photographs IMG_618 and IMG_619, the logged area, located in the southeast quadrant of the Site, included stumps, woody debris, and vegetative cover. Soil disturbances over one (1) acre or other industrial activities were not identified at the time of the CEI.

Photographs IMG_0618 and IMG_0619: Vegetative cover over the logged area in the southeast area of the Martville Mine site. Photographs were taken facing east and southeast, respectively.

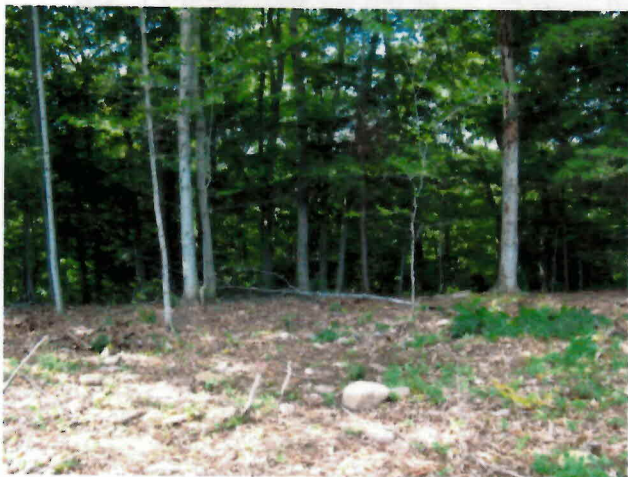
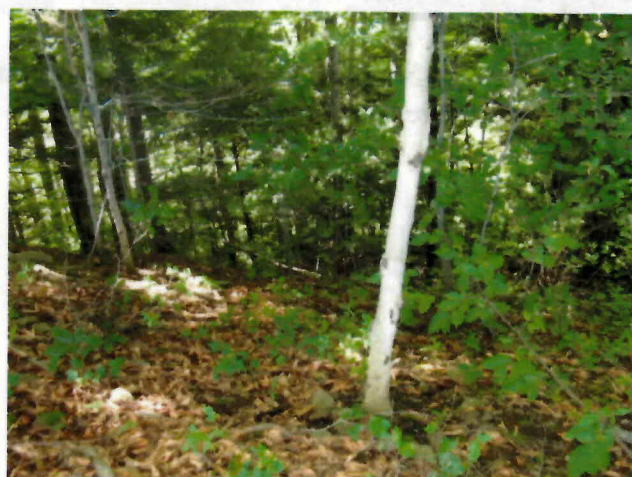
Photographs IMG_0620 and IMG_0621: IMG_0620 identifies the southern limits of the logged area and approximate LOM boundary near the southeast corner of the Site, approximately 360 feet away from Sterling Creek. IMG_0621 identifies steep slopes on the south side of the Site, just beyond the tree line identified in IMG_0620.

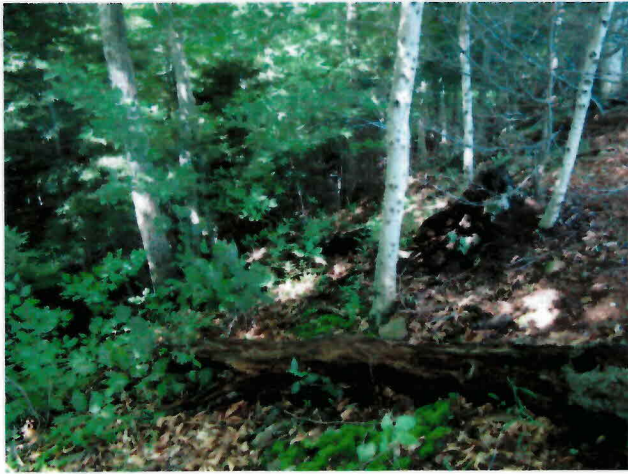
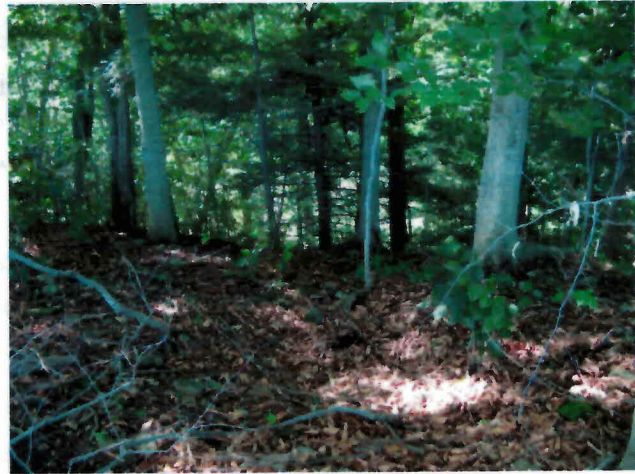
Photographs IMG_0622 and IMG_0623: Steep slopes on the south side of the Site. No discernable flow path was observed on the slopes at the time of the CEI.

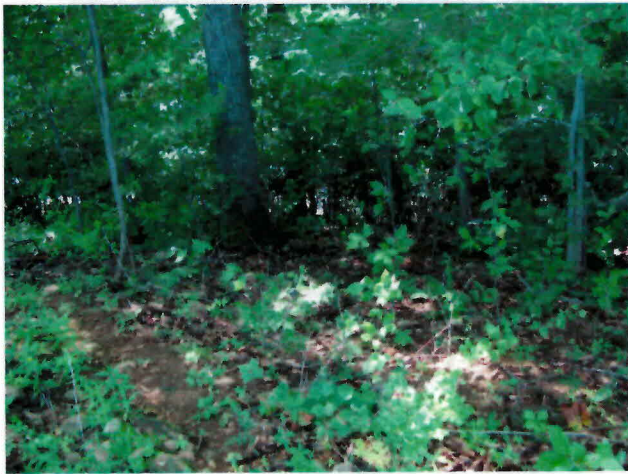
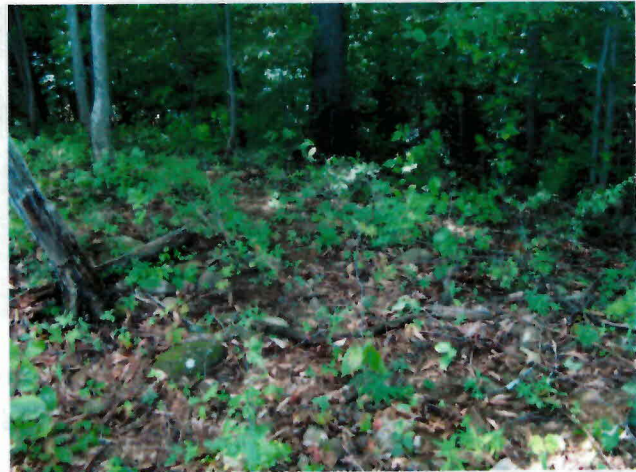
The EPA inspector inspected the south and southeastern areas of the Site for areas where stormwater may discharge from the Site to the wetland or to Sterling Creek. The area that has been logged is relatively flat, and stormwater coming in contact with the logged area of the Site appeared to predominantly infiltrate. No evidence of sediment or sediment-laden stormwater flowing down the slopes of the Site was identified at the time of the CEI. Any stormwater flowing down the slopes on the south and southeastern sides of the Site appeared to be conveyed via sheet flow, as no clear, discrete conveyances from the logged area to, or down, the slopes of the Site were identified. There was one (1) location near the southeastern corner of the Site where minor erosion was observed. This location is identified in photographs IMG_0624 and IMG_0625 and is slightly obscured by leaf litter. It was discussed during the CEI that this area may facilitate channelized flow from areas of proposed industrial activity to Sterling Creek.

Photographs IMG_0624 and IMG_0625: Potential stormwater outfall location near the southeast corner of the Site, where there is a more direct line of sight to Sterling Creek. Minor erosion was identified at this location.

Prior to commencing industrial activity (including construction activity resulting in one or more acres of soil disturbance) that would result in a point source stormwater discharge from the Site, coverage under the MSGP or other SPDES permit must be obtained.
